The Difference Is Night & Day

Oasis Pools breathes life back into a 40-year-old swimming pool

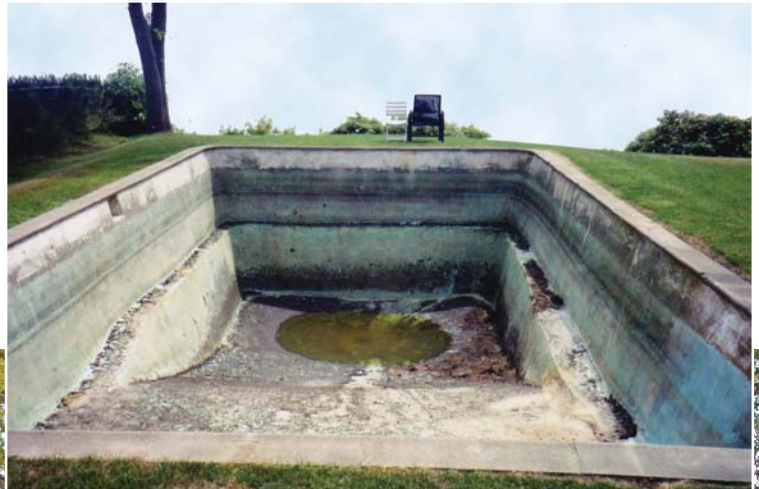
*Right: Before
Below: After*

In order to succeed, in terms of what the client had in mind, Oasis had to perform a complete overhaul of the existing, four-decade old concrete swimming pool that was in extremely poor condition.

To bring the swimming pool back to life, the concrete structure was sandblasted to clean the surface, while new coping, tile, marbelite, staircases, skimmer and circulation lines were added.

The facelift of the old rectangular 6 m x 12 m (20 ft. x 40 ft) dry-pack concrete pool shell also included incorporating a 2.4 m x 3 m (8 ft. x 10 ft.) elevated gunite hot tub, attached to the shallow end, and a 6 m x 1.8 m (20 ft. x 6 ft.) lower gunite vault at the deep end for the spill over edge.

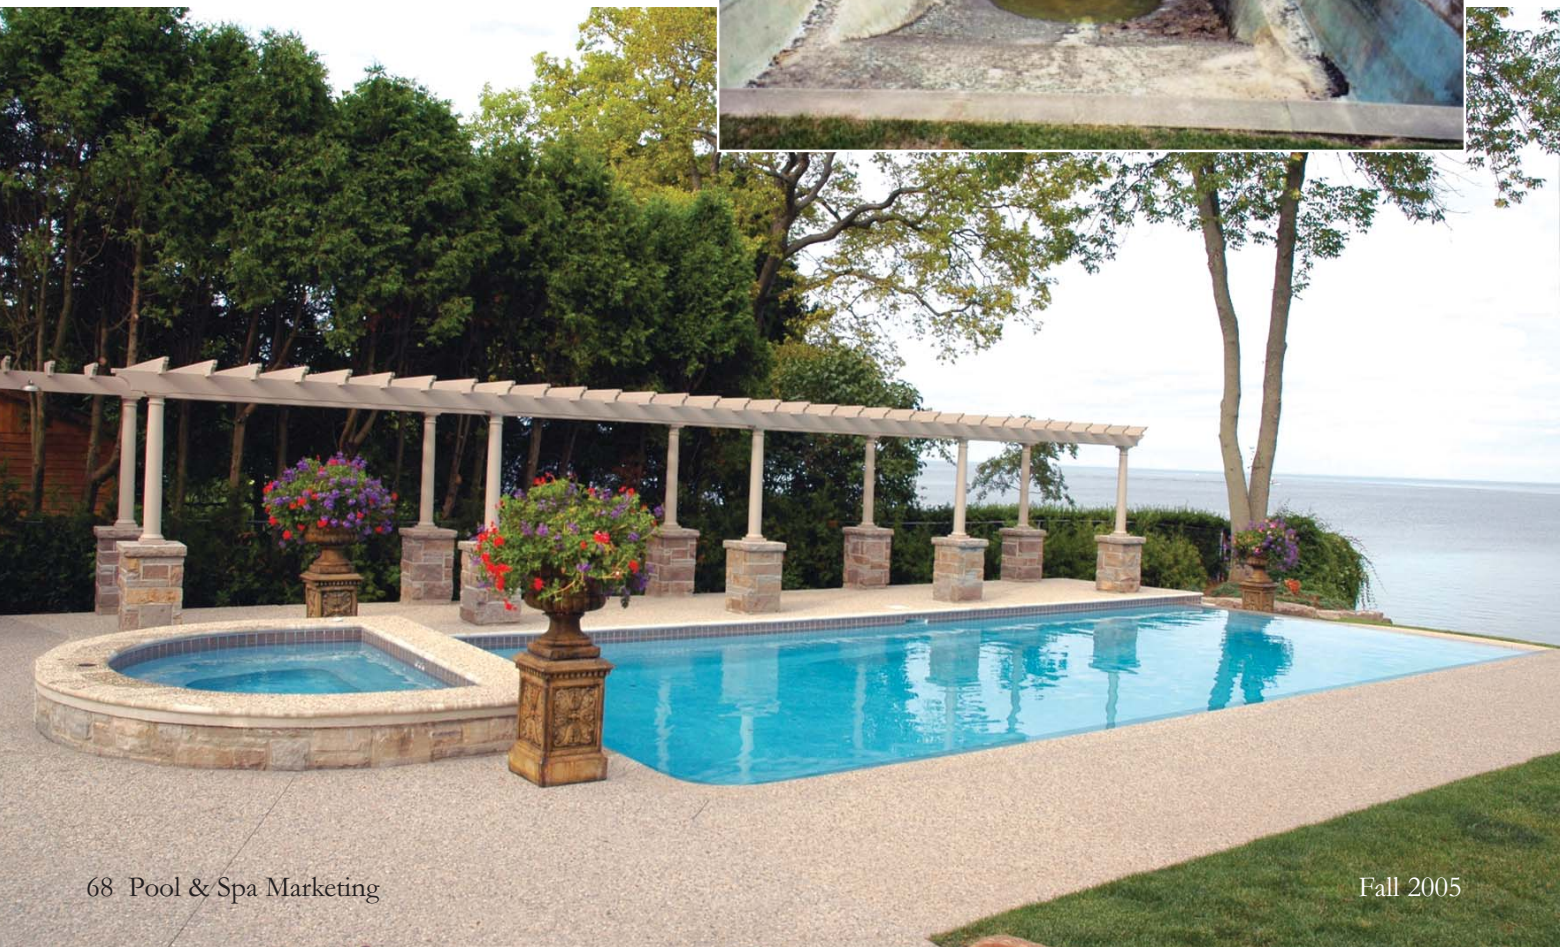
The 1.1 m to 2.4 m (3 ft. 6 in. to 8 ft.) deep pool features dual corner staircases, a formed and poured seeded exposed aggregate coping, and porcelain mosaic tile border. The interior of the entire structure is finished in a 3M Colorquartz marbelite aggregate to generate a deep blue tint; while approximately 279 sq m (3,000 sq. ft.) of multi-level exposed aggregate decking along with significant areas of Wiarnton flagstone surrounds the pool area.

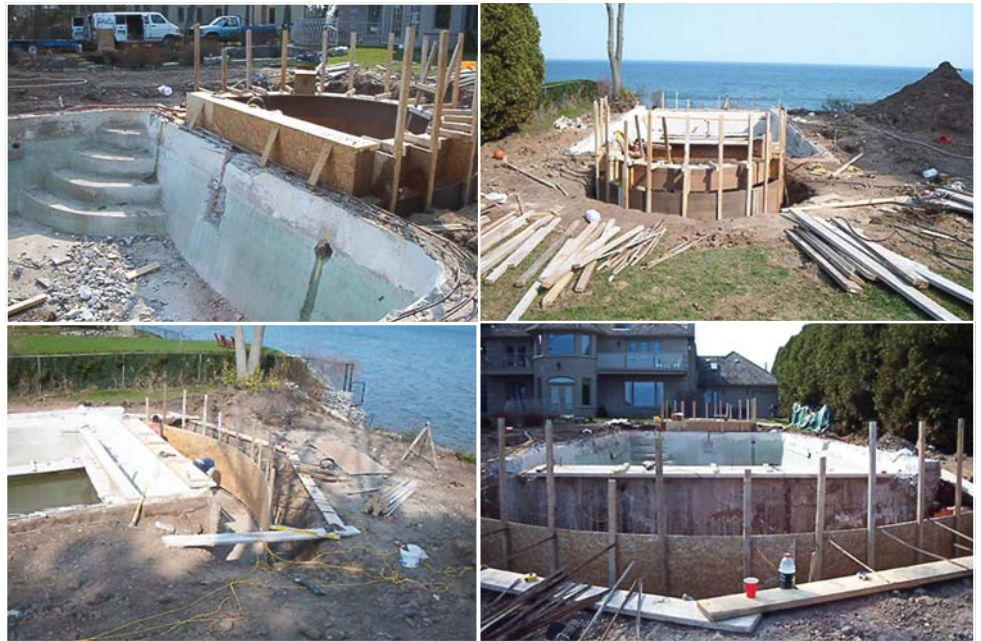
Various stages of restoration: In order to succeed, in terms of what the client had in mind, Oasis had to perform a complete overhaul of the existing, four-decade old concrete swimming pool that was in extremely poor condition. To bring the swimming pool back to life, the concrete structure was sandblasted to clean the surface, while new coping, tile, marbelite, staircases, skimmer and circulation lines were added. The facelift also included incorporating an elevated gunite hot tub, a spill over edge and dual corner staircases.
